# Confidential Technical Report

PROJECT NO: K1081

UV EXPOSURE OF SIMULATED BRICK MATERIAL

## UV Exposure of Simulated Brick

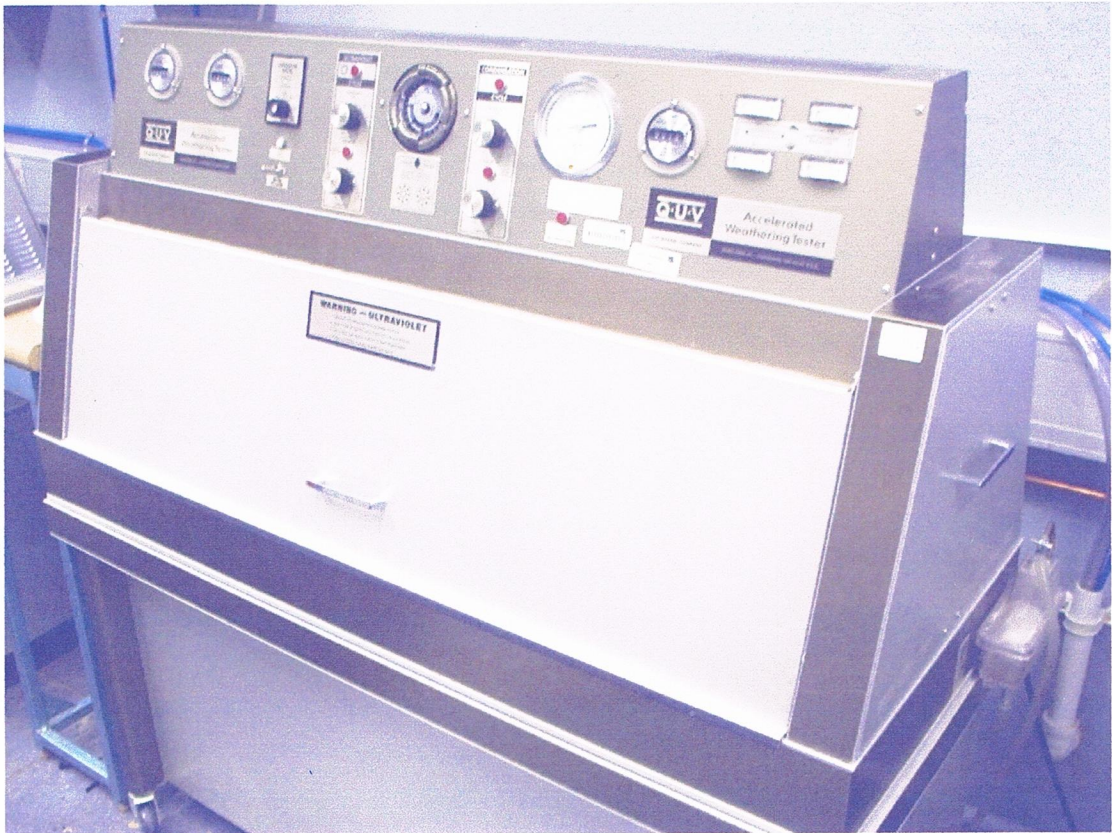
Q-Panel UV Exposure Cabinet

As detailed above the test pieces were mounted into a Q-panel weathering apparatus fitted with UVA 340 lamps. These lamps were chosen, as they are a close simulation to UV light on earth's surface. The apparatus was set to operate on a 4 hourly cycle, 4 hours UV followed by 4 hours condensation. The temperature during each cycle was set at 50°C. Testing was carried out in general accordance with ISO 4892-3:2000.
